Inspection Report

Condo Sample Report

Property Address:
Any Drive #123456.
Anytown OHIO 55555

Winkleman Home Inspections

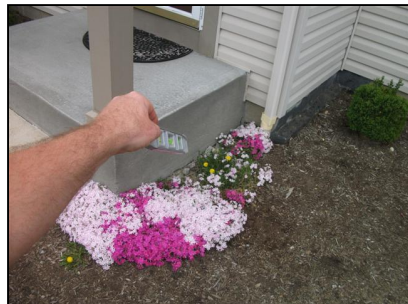
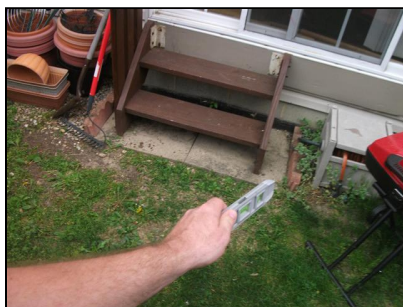
2.4 The steps at the exterior are inconsistent and/or are too high or low, which present a potential trip/fall hazard. It may not be cost effective or realistic to adjust or make proper. There is a definite cautionary and still, a recommendation to have the inconsistency adjusted as needed for safety. To be properly addressed by a qualified company.

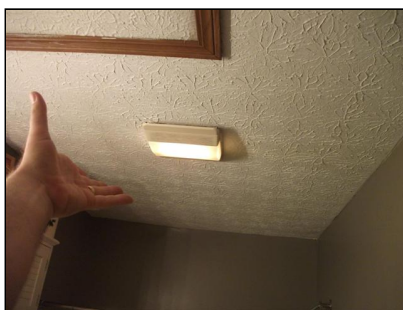
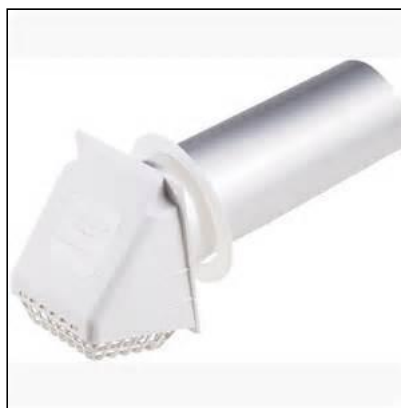
(2) I did not observe any vents at the exterior of the building indicating a proper bath vent exit. *It is recommended that the bath fan be brought to a permanent termination point at the exterior of the building, not just into the attic or to the eaves. Also, the main bathroom vent itself is loose and coming down. Proper securement is recommended for function and safety. All mentioned in this statement to be done by a qualified person or company.*

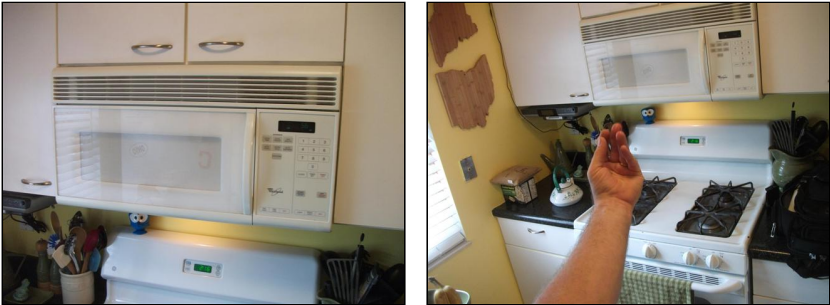
4.1 The oven is working as intended. I did not notice any major, only minor cosmetic damages to the unit. The existing oven/range/stove limited the inspection of the utility installation due to scope of work, design or alternate obstruction. Unable to verify proper set up of gas/electric installation or alternate possible issues (rights or wrongs). There were also not any observed anti-tip brackets, which should be properly installed for safety. **I recommend further inspection and addressing by an alternate company, for properness.**

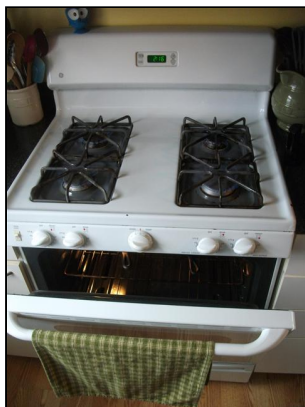
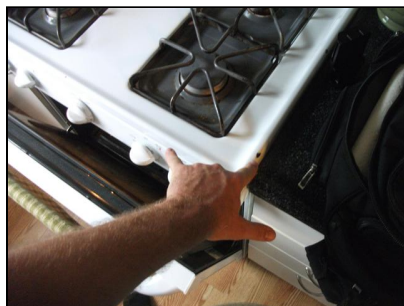
4.2 Ran and works. I did not notice any major cosmetic damages to the unit. The appliance appears at or beyond it's life expectancy. Soap dispenser does not appear to be operating as intended. *Further address as desired.*

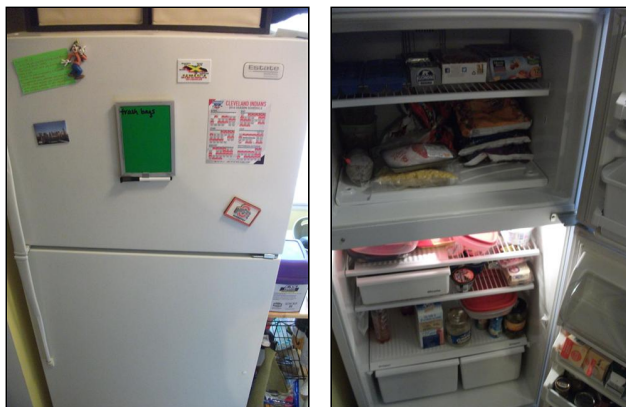
4.4 The refrigerator was observed and appears to be operating. *I did not notice any major cosmetic damages to the unit.* FYI-

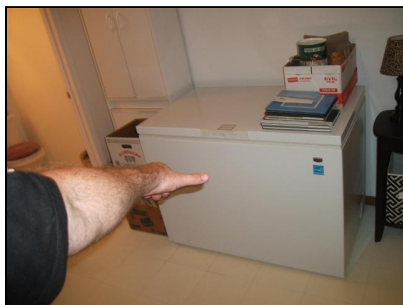
4.5 I did not inspect any part of the extra refrigerator/freezer or it's related components. FYI-

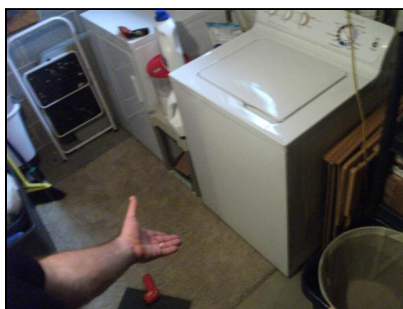
The clothing washer does not have a back up drain pan. **In general it is recommended and should be properly installed by a professional for function.**

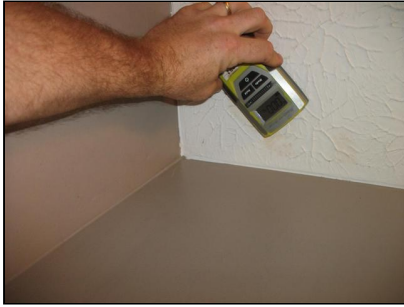
5.0 I observed the ceilings of the home. There are some existing tape cracks, ceiling tile damages and various stains that appear to be from settling, improper installation and/or past moisture issues, deemed cosmetic at this time. *Monitor and further address as desired.*

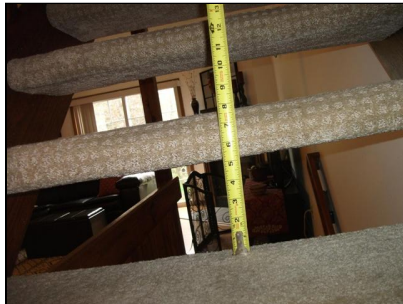
5.3 Stairs/steps that have open risers and are not safe for children. Risers may be open, but should not allow the passage of a 4-inch diameter sphere. **I recommend properly addressing as needed for safety by a qualified contractor.**

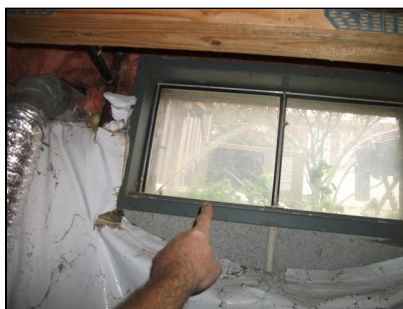
(2) The kitchen window appears to have a broken seal or cloudiness appearance. This impairs view abilities and effects the efficiency of the windows. *Repair/replace as desired. To be done by a qualified person or company.*

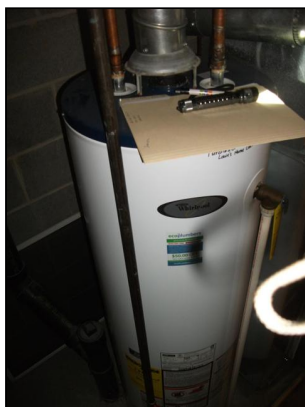
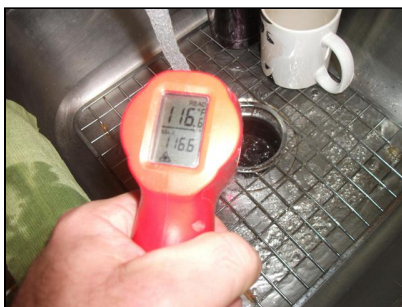
6.1 The HWT has been tested for temperature reach. It has reached an expected temperature reading. As temperatures can be adjusted at most HWT's, *I recommend that the temperature be a maximum of between 120-125 F for safety and efficiency.*

-Your water heater does not have a "Thermal Expansion tank" installed to prevent a possible leak at the T&P or "pop-off" valve or explosion. Recent changes generally require one to be installed, when a new water heater is installed (localities and systems may vary). There were no leaks or drips at the T&P valve during inspection. If your water heater does begin to drip or leak, then a thermal expansion tank may be needed. *As a suggested upgrade, it is recommended that an expansion tank be installed anyway. To be done by a qualified plumber or company.*

-*The tank does not have a recommended proper overflow/drain pan system installed for water common overflow prevention. To be done by a qualified plumber or company for function if so desired.*

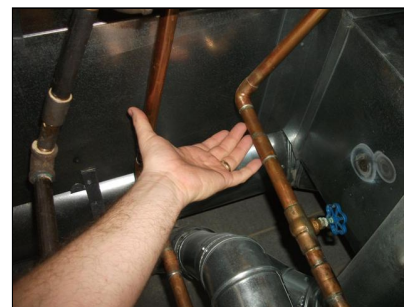
6.2 (1) Observed PolyButylene plastic plumbing supply lines (PB) are installed in the subject house. Polybutylene has been used in this area and others for many years, but has had a higher than normal failure rate and is no longer being widely used. Obviously water leaks can produce minor to major damages. Copper and Brass fittings used in later years have apparently reduced the failure rate. *For further details, it is recommended to contact the Consumer Plumbing Recovery center at 1-800-392-7591 or the web at <http://www.pbpipe.com>*

It is also recommend to consult a licensed plumber for quoting to address/replace the material, as found needed.

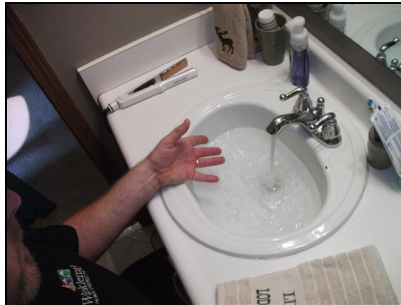
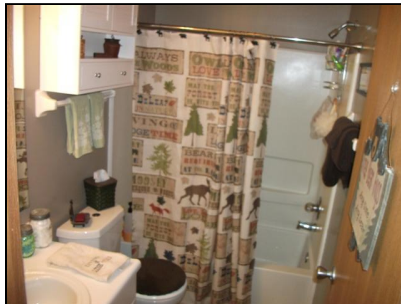
6.3 (1) There is a musty smell in the upstairs bathroom. It is suspected of coming from the drains. The tub drain material is corroded and the sink is slow. I recommend further proper addressing for function. **More than likely by a qualified plumber.**

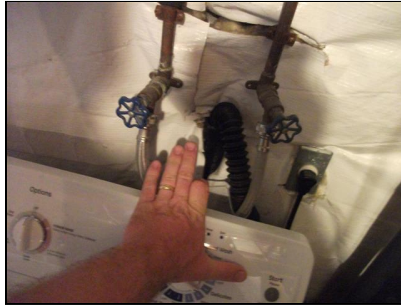
(3) The observable clothing washer drain is less than 2". This may not be adequate for modern, higher efficiency washers. *I recommend checking the manufacturers specifications from your particular appliance, as alterations or increases from the drain pipe may need made. Further address as desired for function. If found needed, repairs are to be completed by a licensed plumbing company.*

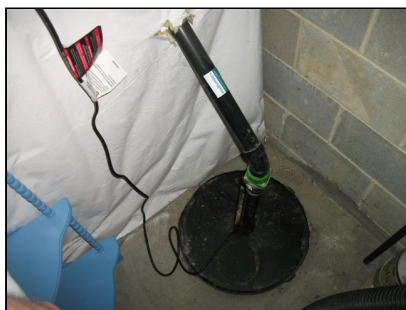
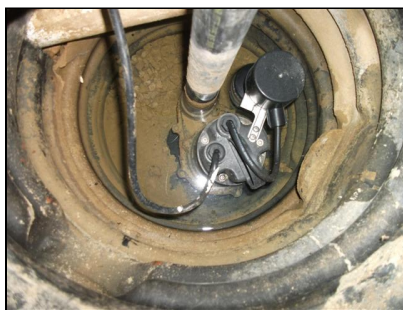
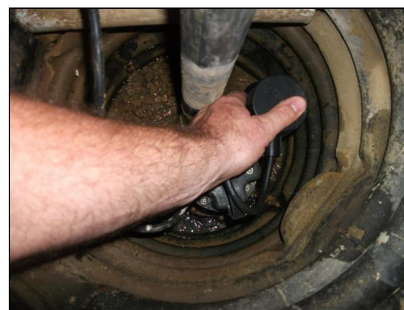
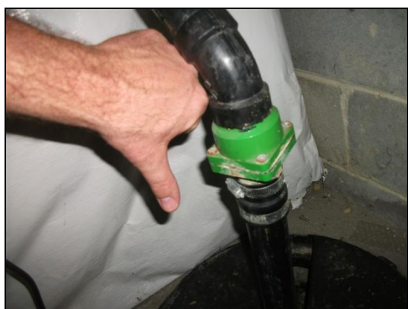
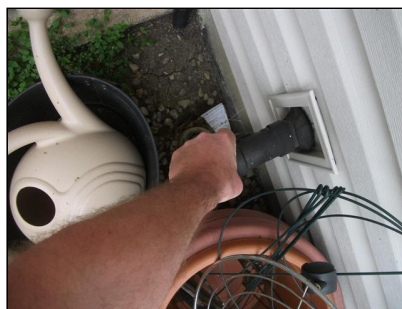
The check valve for the sump pump system does not appear to be working properly and should be replaced.. **I recommend that one be properly installed by a qualified person for function.**

The exterior discharge of the sump system is loose. This system is vital to water distribution away from the home. **This should be properly corrected by a qualified person for function.**

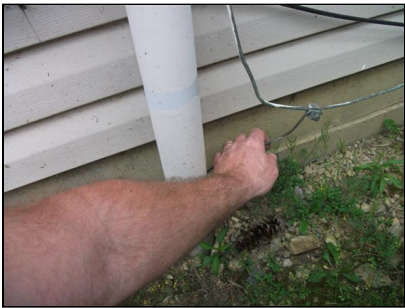
7.0 The visible service line/area was inspected and deemed in good/typical condition. FYI-

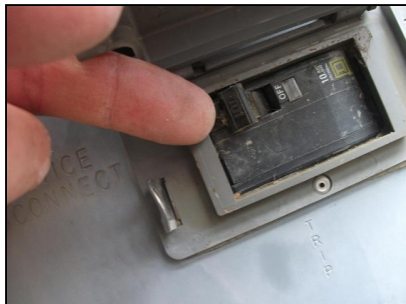
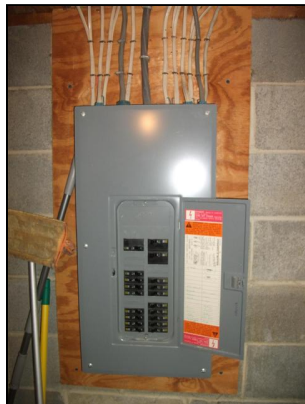
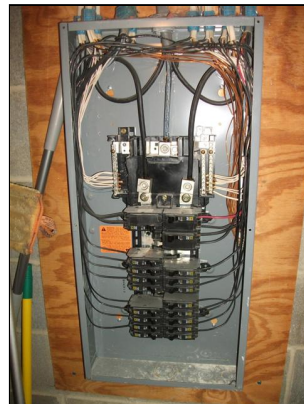
7.1 The main service entrance and main breaker for the electrical system is located at the exterior side of the building/units. The breaker panel is located in the basement near the other utilities. *FYI-*

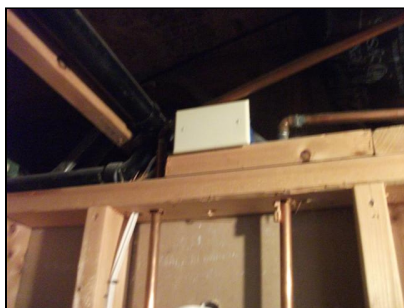
7.4 There are observed receptacle/junctions throughout the home that are covered and I did not verify any installation or connections beyond. *Inspect further as needed, commonly used as a wiring junction, covered fixture plate or common ceiling fan/light. To be done by a licensed electrician or company for function and safety, if so desired.*

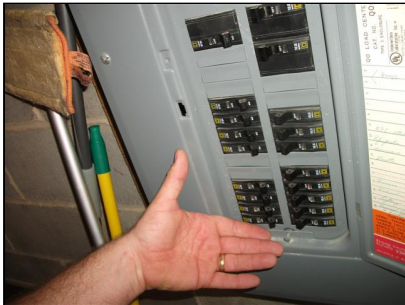
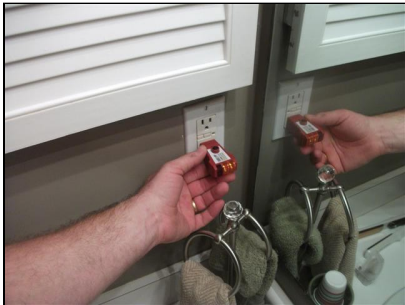
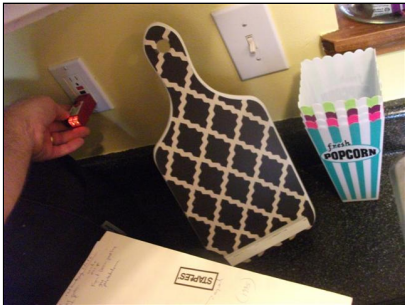
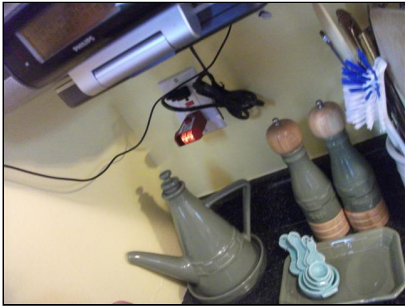
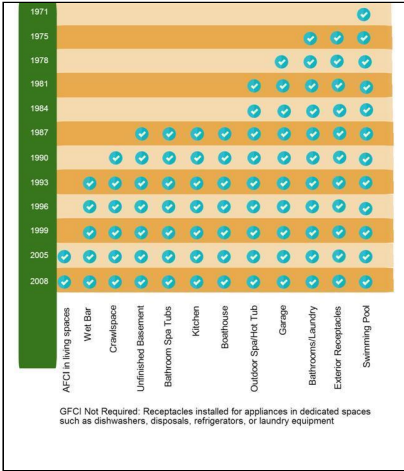
7.6 (1) No AFCI's (Arc Fault Circuit Interrupters, purposes of basically bedrooms) were observed at the breaker panel. Not common for the time of construction. (Generally residential builds 2002 and newer.) **I recommend to upgrade, as needed, for function and safety, after further consultation by a licensed electrician, if so chosen.**

The observed GFCI/GFI's were tested. There are receptacles that are connected to a centralized GFCI (test, trip button, usually black and red, sometimes white and white). Your home has circuitry connected at the following locations; *Bathroom and kitchen.*

GFCI receptacles were required in houses starting in 1971. Originally they were only required at the exterior of the house and by swimming pool equipment. Over the years, GFCI receptacles have been required in more locations such as garages, bathrooms, kitchens, etc. Attached, is a more modern, GFCI location Chart. In an older home there may be no requirement for GFCI's to be installed. I do recommend *upgrading certain receptacles to GFCI receptacles*, please know that this feature is a recommended safety/function upgrade as are the previously mentioned AFCI's. **A licensed electrical company should inspect and address/install as needed for function and safety, after further consultation.**

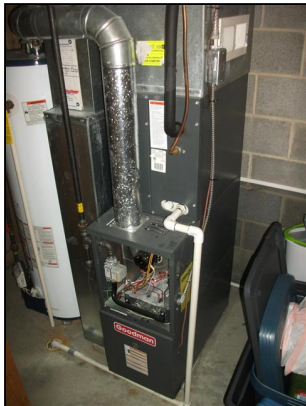
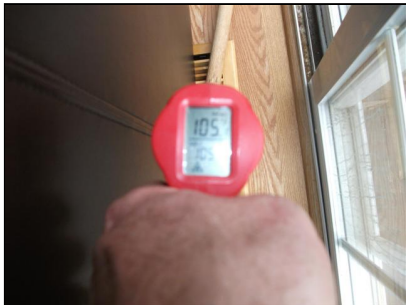
105 F Heat

8.0 The expected temperature variance is between 30-60 degrees for most modern furnaces/heat pumps. *Your temperature drop was indicating a normal function. FYI-*

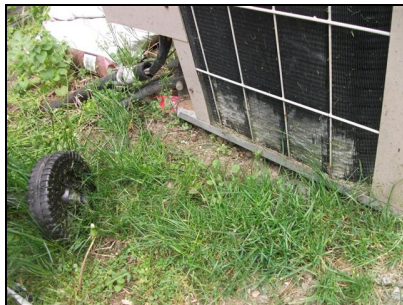
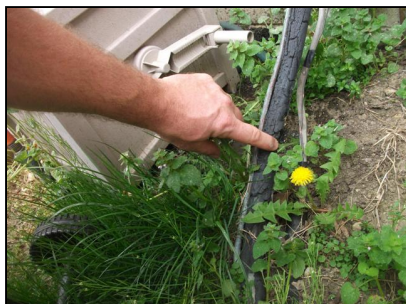
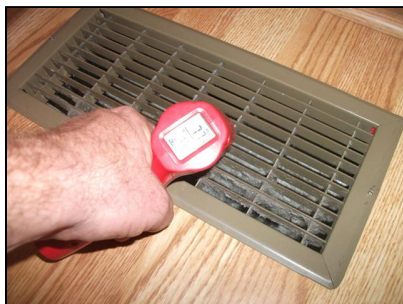
8.1 The air conditioning system was physically observed and only minor damages were observed. The installation appears proper, but the unit appears aged or beyond it's normal life expectancy. The expected temperature drop is between 14-22 degrees for most modern air conditioners. *Your temperature drop was indicating a normal function. FYI-*

Other observation and recommendations: The condenser outside (AC unit) appears aged. *A unit such as yours, is recommended to have a yearly check up performed. Further address as desired.* The service disconnect for the outside condenser is missing a recommended small padlock for the preventative reason of unwanted entry to the hidden high voltage or switch. *Install as needed for safety.* The foam sleeve on suction line is missing foam sleeve in area(s) at outside unit. Missing foam on suction line can cause energy loss and condensation. *I recommend service or repair as needed.* Electrical lines should ideally be placed into a protective sleeve or conduit for properness. *Further address as needed. To be done by a proper, licensed HVAC company for safety and/or function, as desired.*

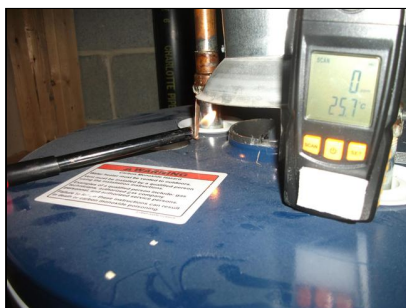
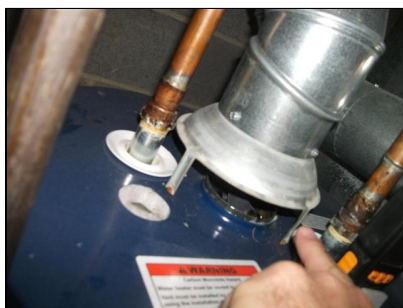
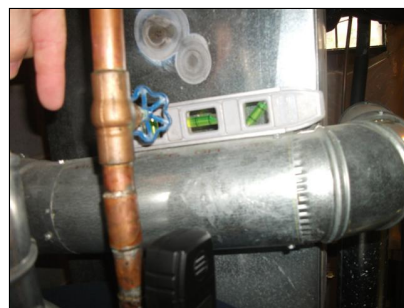
8.3 (1) A basic, common, draft test was performed at the HWT flue. *It seems as if the draft pull is proper. FYI-*

The flue vent pipe for the HWT is not installed correctly, it is loose. Also, the furnace flue pipe flows downward. Both of these mentioned items can allow carbon monoxide to not exit the building properly and present a hazard to the occupants. *The flue needs to be properly adjusted and re-installed for proper function and safety. To be completed by a licensed HVAC company.*

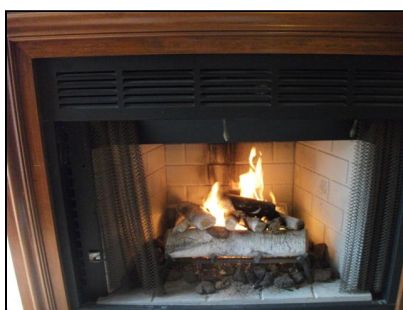
8.6 The fireplace was able to be lit. FYI-

I do not test or inspect proper log placement or ODS (Oxygen Depletion Sensor) systems. *All units, gas, conventional wood, vented or "non-venting" fireplace set ups should be inspected by a specific fireplace professional on a regular or yearly basis for safe operation and functional verification.* **I recommend this be done now and at a regular interval for proper function and safety. I also recommend reading and understanding the manufacturer's instruction and specifications before the first use of any gas/propane fireplace.**
