# Inspection Report

## Sample 2018 General

**Property Address:**  
12345 Anystreet  
Anytown Ohio 13254

## Winkleman Home Inspections

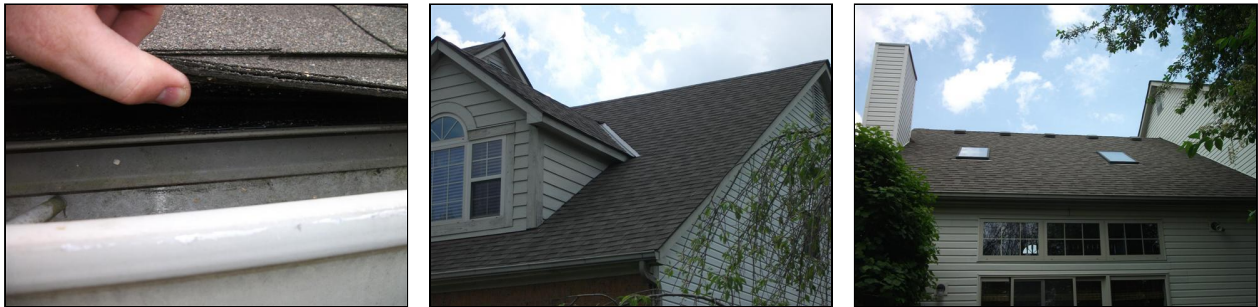
**1.0** The roof appears to be recently installed. There are no observed installation defects. *The only thing noticed are that some nail heads need re-covered/sealed in various areas. To be properly completed by a licensed roofing company when completed.*

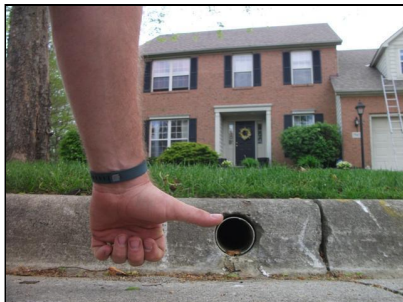
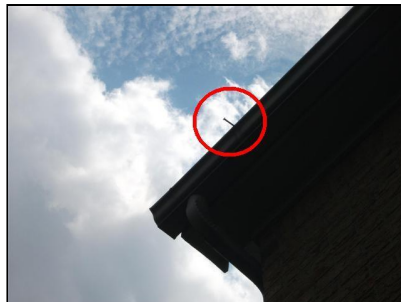
**1.1** Some adjustments are needed at the gutters themselves. *Repair/replace as needed. To be done by a qualified person or company.*

Some adjustments are needed at the gutters themselves. *Repair/replace as needed. To be done by a qualified person or company.*

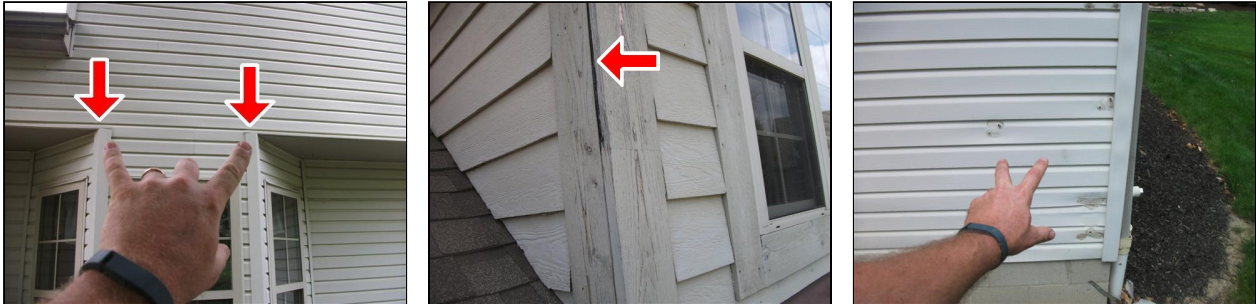
**2.0** (Minor) Some of the exterior cladding (trim, siding, brick, doors, windows etc.) has maintenance opportunities throughout the exterior. *May need repaired, replaced, paint scraped, priming, painting and caulking. Including windows and door areas. Any areas of penetration, such as air conditioning lines, sump pump lines, vents and electrical entrances also need sealed properly. Moisture, weather and pest intrusion and related issues may occur at a higher rate if not properly maintained. Tend to as needed by a qualified person, as needed for function.*

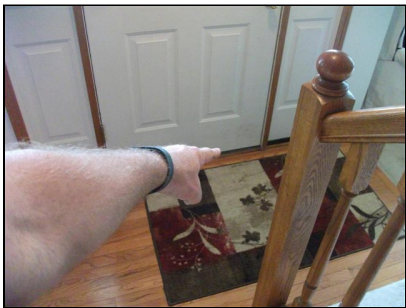
**2.1** (1) *The exterior door(s) are in need of some weather stripping and/or adjustment in areas.* Lack of, or neglect, may contribute to unwanted moisture and weather elements into the home, possibly increasing utility bills or damaging the structure.

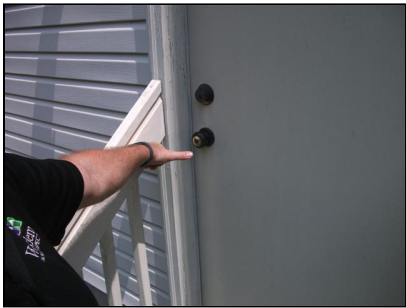
(2) The garage exterior, occupant door was not inspected due to obstruction from inside the garage. *Further inspect as desired, once conditions improve.* FYI-

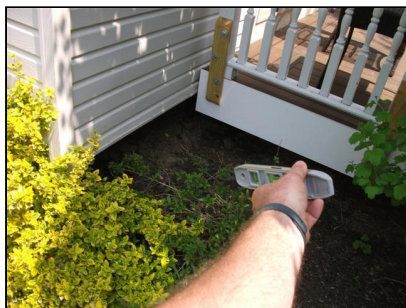
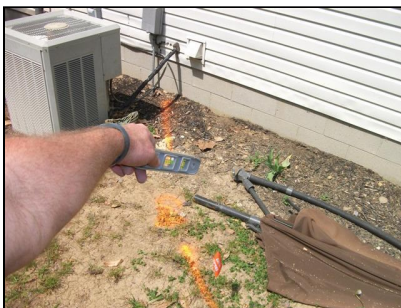
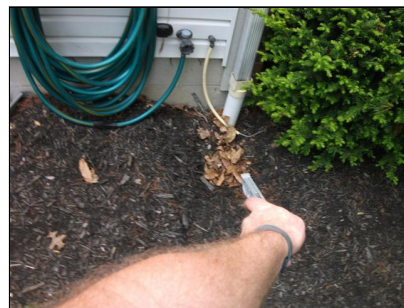
**2.3 (1)** Areas of home need landscaping, grading and drainage improved due to potential excess moisture suspected at the exterior of the home, which typically leads to water/moisture intrusion and alternate moisture related issues. The landscape at the front, rear and sides of home may require a trench or drain if water stands or puddles after heavy rain. *As a general recommendation, improve the slope around the home on a regular basis. To be done after further evaluation and after a moisture or weather proofing paint is applied against the foundation.*

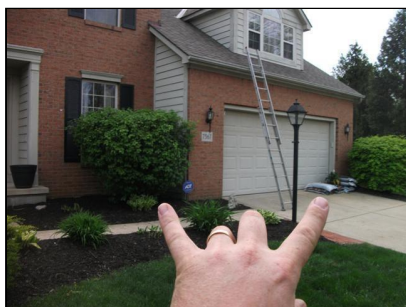
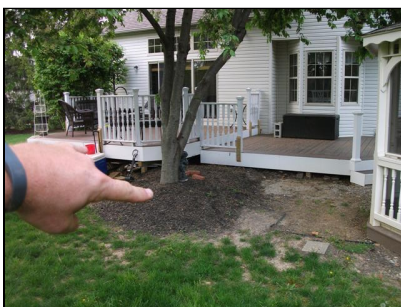
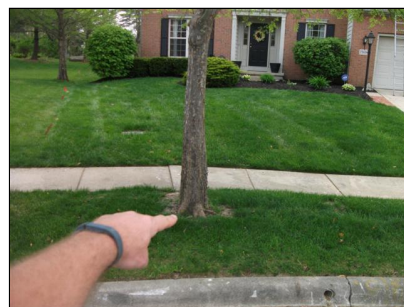
(2) Large trees present on the property near the home. Aesthetically pleasing but may cause pressure on the foundation, create clogs in septic and other drain lines and may drop branches on the roof. *Trim and tend to on an as needed basis. To be done by a qualified person or company.*

Also, due to possible water and/or pest intrusion and pre mature wearing of the cladding, *it is recommended that all shrubbery be trimmed back at least 6-12 inches away from the house. To be done by a qualified person or company.*

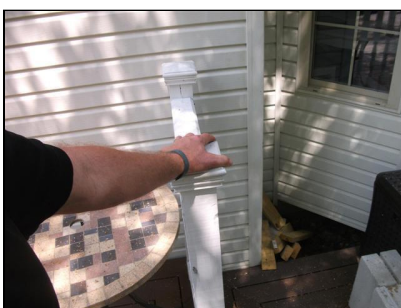
**2.4 (1)** The guard rails are loose at the exterior rear deck. *I recommend that they be properly secured for safety. To be completed by a qualified person or professional.*

(1) The guard rails are loose at the exterior rear deck. *I recommend that they be properly secured for safety. To be completed by a qualified person or professional.*

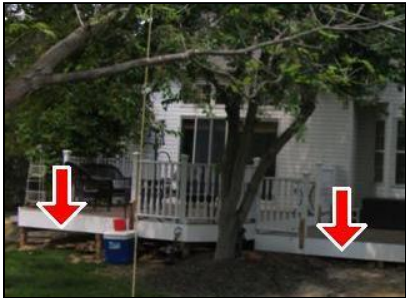
(2) The exterior deck steps are not complete. I recommend that these items be properly installed for function and safety by a qualified contractor.

(2) The exterior deck steps are not complete. **I recommend that these items be properly installed for function and safety by a qualified contractor.**

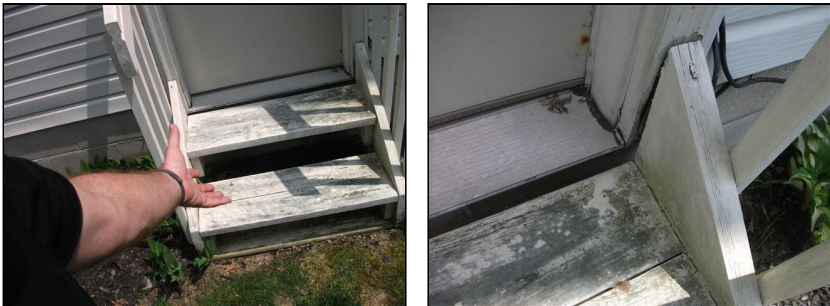
(3) The side steps are a builder grade temporary fixture. I recommend it/them to be replaced and brought up to proper standard's. To be completed by a qualified person or professional.

(3) The side steps are a builder grade temporary fixture. *I recommend it/them to be replaced and brought up to proper standard's. To be completed by a qualified person or professional.*

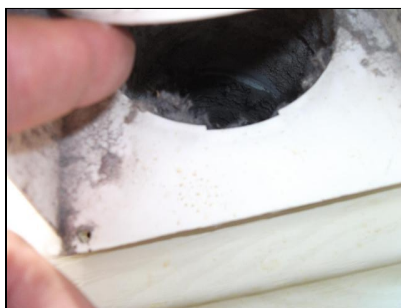
**3.4** The dryer vent appears to be dirty. *I recommend cleaning and then checking once a month for watching of lint build up which is a potential fire hazard. To be done by a qualified person or company.*

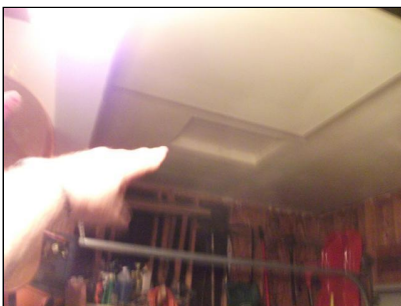
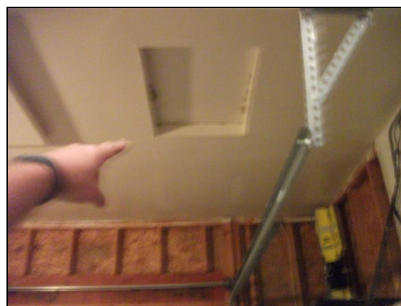
**4.1** The attic accesses that are located in the garage are in the path of the actual garage door. **Caution.** This poses a safety issue if the door is opened when an occupant is using the ladder. This poses a serious injury or death hazard. I recommend permanently addressing the stairs/issue as found needed by a qualified company for safety.

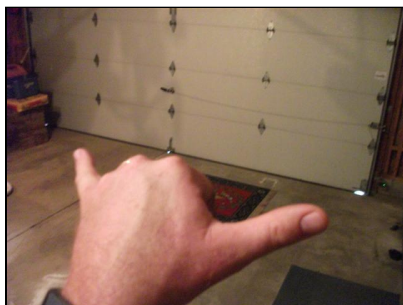
**4.3** The garage door is in need of weatherstripping. I recommend that this item(s) be installed for efficiency and pest prevention reasons. To be completed by a qualified person.

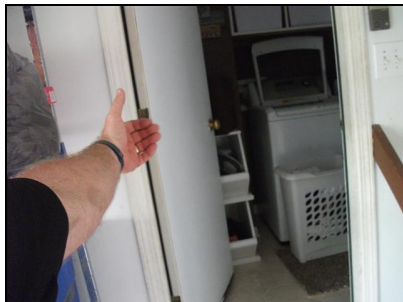
**4.4** (Though not common)- The garage occupant door does not have an additional recommended, automatic door closure system/hinges. *Install a proper product as needed for safety. To be done by a qualified person or company.*

The garage occupant door is missing seals around the casing. *I recommend that they be added to help prevent possible dangerous fumes from entering the dwelling as well as prevent possible explosion reactions. To be done by a qualified person or company.*

(Though not common)- The garage occupant door does not have an additional recommended, automatic door closure system/hinges. *Install a proper product as needed for safety. To be done by a qualified person or company.*

The garage occupant door is missing seals around the casing. *I recommend that they be added to help prevent possible dangerous fumes from entering the dwelling as well as prevent possible explosion reactions. To be done by a qualified person or company.*

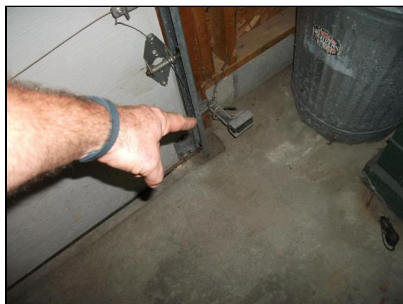
**4.5** The garage door reverses when the safety beams are crossed. The safety beams are too high though. They should be re adjusted to the height of 6 inches. Also, the garage door and opener did not retract when tested for moderate resistance. *I recommend that the above mentioned features be fixed to prevent any possible injuries. To be done by a qualified company.*

The garage door reverses when the safety beams are crossed. The safety beams are too high though. They should be re adjusted to the height of 6 inches. Also, the garage door and opener did not retract when tested for moderate resistance. *I recommend that the above mentioned features be fixed to prevent any possible injuries. To be done by a qualified company.*

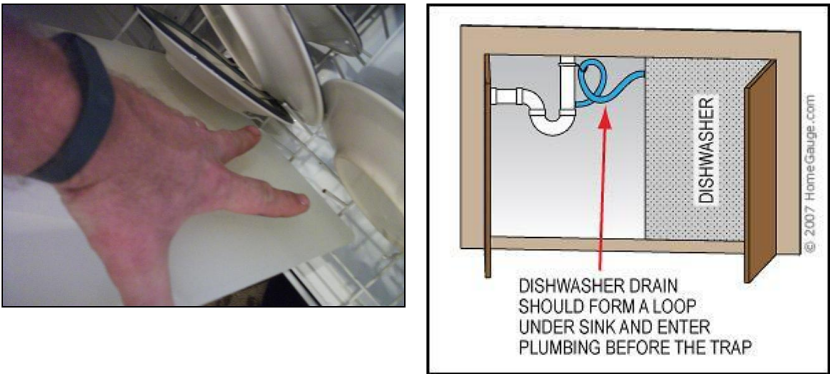
5.0 The dishwasher was ran and seems to work fine. The racking is starting to show signs of deterioration. The washer is also missing a recommended drain loop. *Monitor and repair/adjust as desired.*

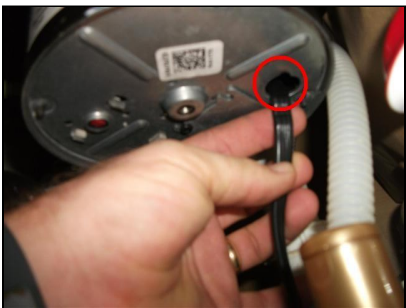
5.1 The disposer was operated and works fine. FYI-

The food disposer wiring is missing a romex connector (anti-strain device). *I recommend repair as needed. To be done by a qualified appliance repair company.*

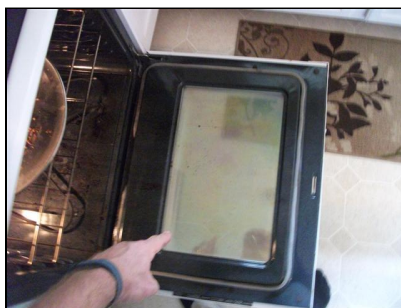
**5.2** The oven is working as intended. I did not notice any major cosmetic damages to the unit. Missing the safety clips at the rear of the unit. *I recommend that these be installed for injury prevention. To be done by a qualified appliance repair company.*

The oven is working as intended. I did not notice any major cosmetic damages to the unit. Missing the safety clips at the rear of the unit. *I recommend that these be installed for injury prevention. To be done by a qualified appliance repair company.*

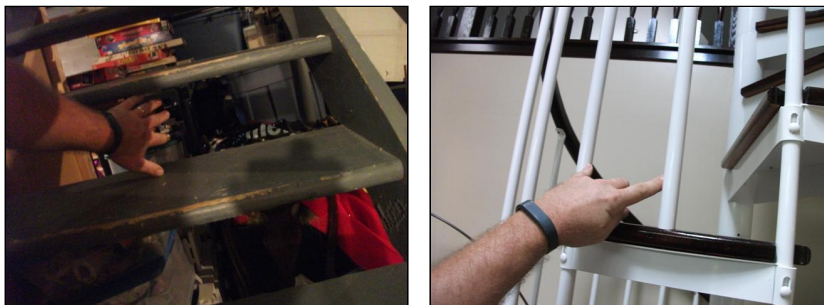
**6.3** Stairs/steps that have open risers and balusters and are not safe for children. Risers/baluster spacing may be open, but should not allow the passage of a 4-inch diameter sphere. **I recommend properly addressing as needed for safety by a qualified contractor.**

Stairs/steps that have open risers and balusters and are not safe for children. Risers/baluster spacing may be open, but should not allow the passage of a 4-inch diameter sphere. **I recommend properly addressing as needed for safety by a qualified contractor.**

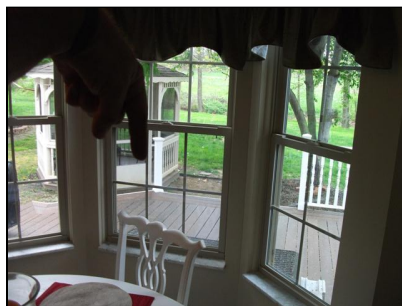
**6.6** The window at the center, kitchen bay, is not operating as intended and falling down and is considered a safety issue. *I recommend properly addressing the window for function and safety. To be done by a qualified person or company.*

The window at the center, kitchen bay, is not operating as intended and falling down and is considered a safety issue. *I recommend properly addressing the window for function and safety. To be done by a qualified person or company.*

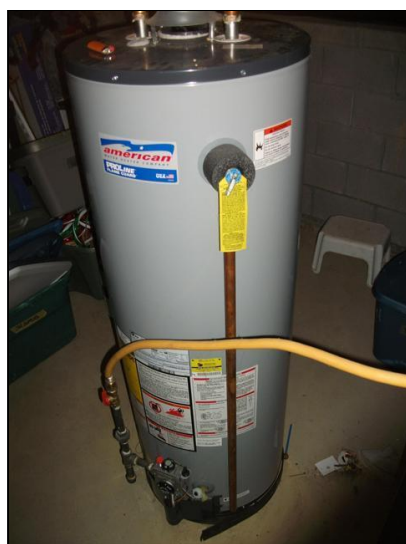
-Your water heater does not have a "Thermal Expansion tank" installed to prevent a possible leak at the T&P or "pop-off" valve or explosion. Recent changes generally require one to be installed, when a new water heater is installed (localities and systems may vary). There were no leaks or drips at the T&P valve during inspection. If your water heater does begin to drip or leak, then a thermal expansion tank may be needed. *As a suggested upgrade, it is recommended that an expansion tank be installed anyway. To be done by a qualified plumber or company.*

-The tank does not have a recommended overflow/drain pan installed for water overflow prevention. **To be done by a qualified plumber or company for function.**

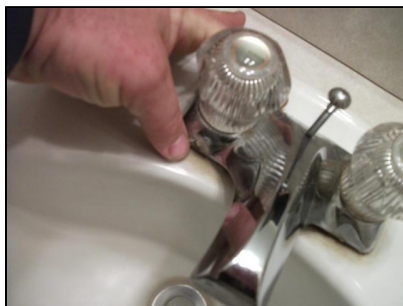
**7.2** (1) Some faucet joints/sections were observed as corroded or starting to corrode. **I recommend that these areas be addressed by a plumber for function.**

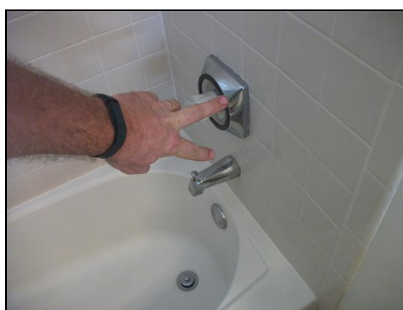
(2) Caulking is needing added and/or cleaned and re-installed at various spots in the bathrooms. I am not able to determine if there is/are any damage(s) from moisture or lack of maintenance to any adjacent areas or materials. *Address as needed. To be done by a qualified person or plumber.*

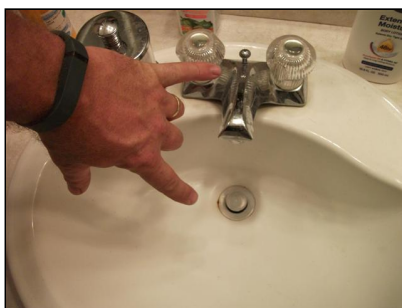
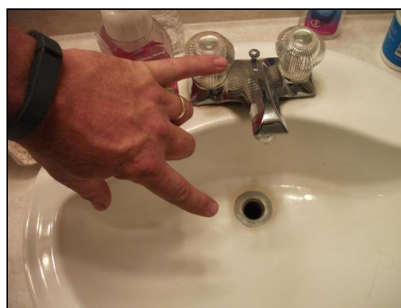
**7.3** (1) The mechanical sink drain stops are missing or are not connected correctly. *Repair or add as desired. To be done by a qualified person or plumber.*

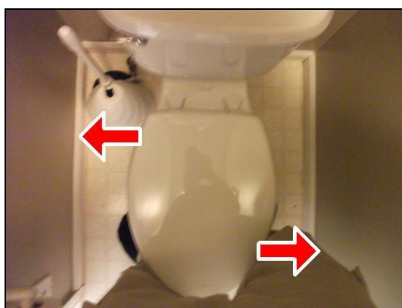
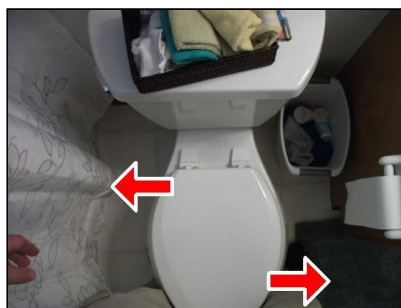
(2) The toilets are missing recommended caulking at floor at the bath(s). *Install the necessary caulking around the front and sides of the toilet base where it meets the floor. To be done by a qualified person.*

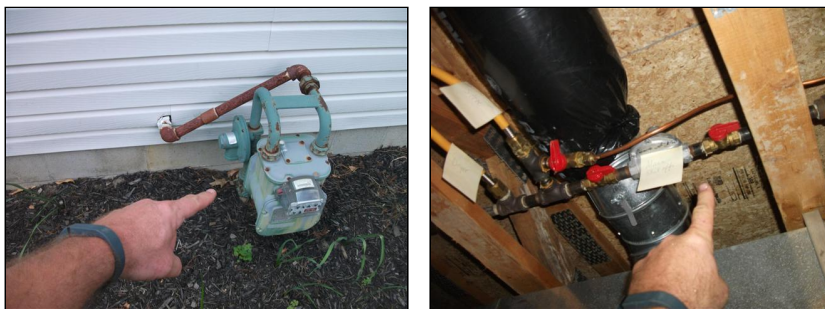
**7.4** The main fuel shut off is at the gas meter outside. *There is an alternate interior shut off at the gas manifold, pictured.*

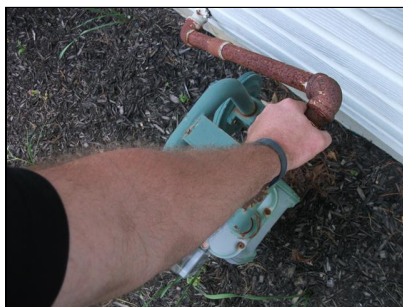
**7.5** The gas line is not bonded. Typical standards recommend bonding of the Corrugated Stainless Steel Tubing (yellow) gas line, due to propensity for the line to break/explode if the home is struck by lightning. *A qualified professional (usually a licensed electrician) should remedy if so chosen.* This aspect of the construction was not required of newly built homes until 2008. This is a preventative measure. *Again, this is a recommended upgrade/safety update. To be done by a licensed electrician.*

The gas line is not bonded. Typical standards recommend bonding of the Corrugated Stainless Steel Tubing (yellow) gas line, due to propensity for the line to break/explode if the home is struck by lightning. *A qualified professional (usually a licensed electrician) should remedy if so chosen.* This aspect of the construction was not required of newly built homes until 2008. This is a preventative measure. *Again, this is a recommended upgrade/safety update. To be done by a licensed electrician.*

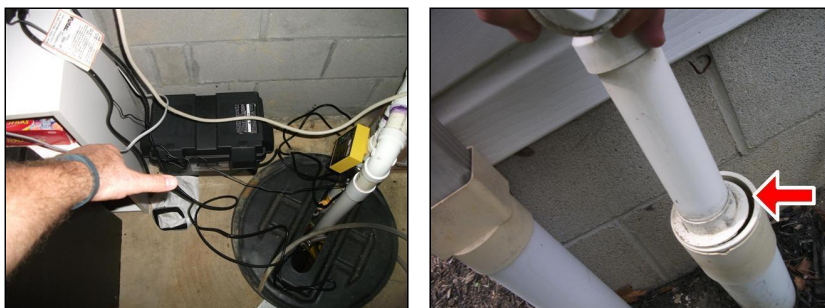
The exterior discharge of the sump system is loose. This system is vital to water distribution away from the home. **This should be properly corrected by a qualified plumber for function.**

Additionally. The sump pump appears to be connected to a battery back up system. These are a helpful feature, but are not inspected/tested during the general inspection process. *Regular maintenance needs performed on this appliance on a regular basis (batteries, testing etc.). I recommend to have a qualified plumber advise further.*

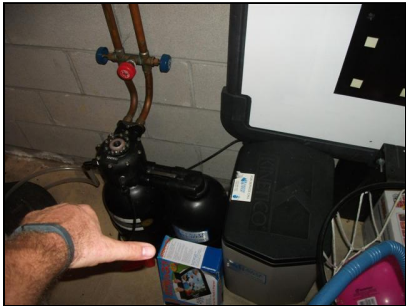
7.7 I did not inspect the whole house water softener fully. I have made the following observations only. I observed no visible leaks and the salt level was empty. *Further address as desired.*

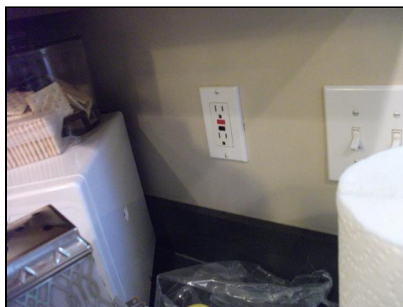
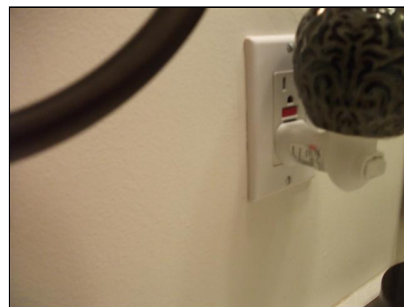
**8.6** Common for a home this age. Some areas were not observed as not having modern safety devices such as AFCI and GF(C)I's at the electrical parts of the home.

(Unless otherwise notated) The observed GFCI/GFI's were tested and functioning as intended. There are receptacles that are connected to a centralized GFCI (test, trip button, usually black and red, sometimes white and white). *GFCI labels were missing on the connected receptacles and recommended to be installed, but not often done.* Your home has circuitry connected to the following locations:

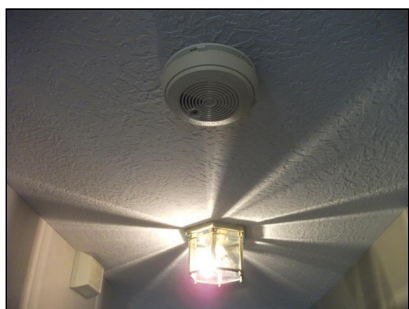
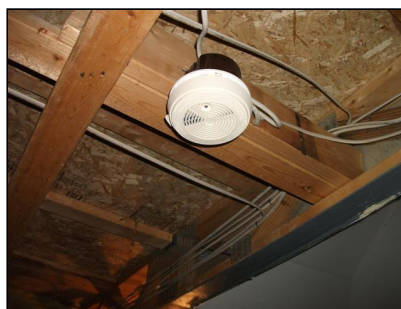
**8.7** I observed the absence of a proper amount of modern working smoke/fire detector/alarm. Without a proper amount of working units in your home, you do not have an adequate, first alert to a possible fire. Multiple smoke/fire detector's should be installed per the manufacturer's instructions and tested upon moving in to home, and tested weekly. **I recommend install as needed for safety by using a qualified electrician. At least one per level and each sleeping area. It is a general recommendation that the smoke detectors be replaced every 8-10 years from the manufacturers date. I do not check the age, further inspect and replace/install as needed. Here is a web site for recommended further reference;** <http://www.nfpa.org/public-education/by-topic/smoke-alarms>

I observed the absence of a proper amount of modern working smoke/fire detector/alarm. Without a proper amount of working units in your home, you do not have an adequate, first alert to a possible fire. Multiple smoke/fire detector's should be installed per the manufacturer's instructions and tested upon moving in to home, and tested weekly. **I recommend install as needed for safety by using a qualified electrician. At least one per level and each sleeping area. It is a general recommendation that the smoke detectors be replaced every 8-10 years from the manufacturers date. I do not check the age, further inspect and replace/install as needed. Here is a web site for recommended further reference; <http://www.nfpa.org/public-education/by-topic/smoke-alarms>**

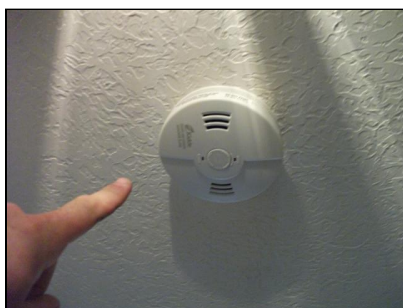
**8.8** There was a carbon monoxide detector in the home. **I recommend having multiple units installed per the recommended manufacturer's instructions and testing once a week and replacing every 5-6 years from the manufacturers date. I do not check the age.**

There was a carbon monoxide detector in the home. **I recommend having multiple units installed per the recommended manufacturer's instructions and testing once a week and replacing every 5-6 years from the manufacturers date. I do not check the age.**

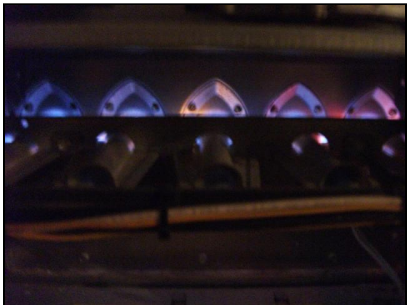
**9.0** The expected temperature variance is between 30-60 degrees for most modern furnaces/heat pumps. Your temperature drop was indicating a normal function. The furnace is approaching the status of aged. **It is recommended to continue having yearly service checks performed by a licensed HVAC company for function and safety.**

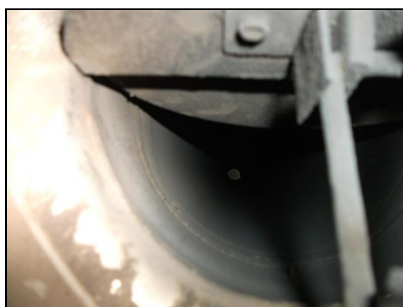
**9.3** The chimney liner for the fireplace was not fully inspected by our company, due to scope. Though appearing open to the top, not all was visible. **It is recommended that a qualified chimney sweep, clean and inspect for safety and function before the first use and address as needed.**

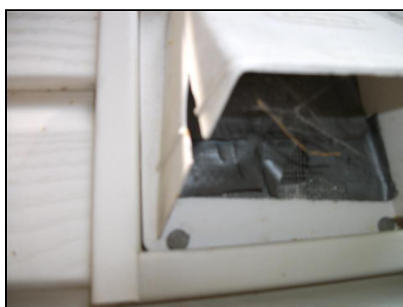
**9.4** The fresh air intake is clogged with debris. *I recommend cleaning off and checking on a monthly basis. Repair as desired.*

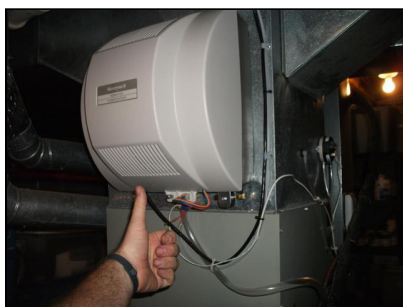
**9.7** The humidifier was tested and appears to be working fine (Moisture coming through the appliance). FYI- *Change pad 1-2 times yearly. Turn damper to the off position in the summer time and adjust humidity to your comfort level.*

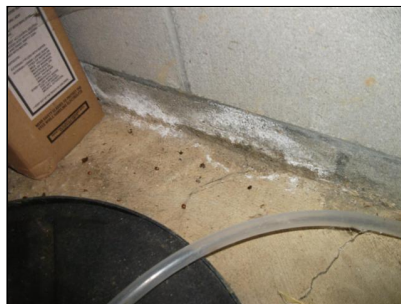
**10.2** Cracks were observed at the interior and exterior foundation walls. No major inflection was observed. *I recommend to properly repair and seal the areas for pest/moisture prevention and future movement monitoring. (Repairs may involve, possible injection, epoxy, replacement)* **To be completed by a qualified person or company for function.**

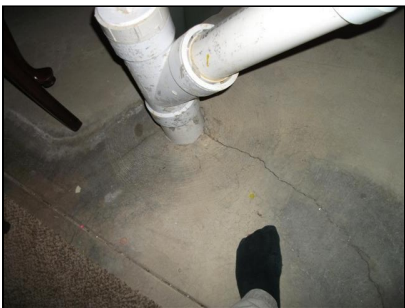
**10.4** Typically viewed cracks in the basement floor concrete *should be properly addressed. Repair/seals as needed for monitoring and vapor/pest intrusion. To be done by a qualified person or company.*

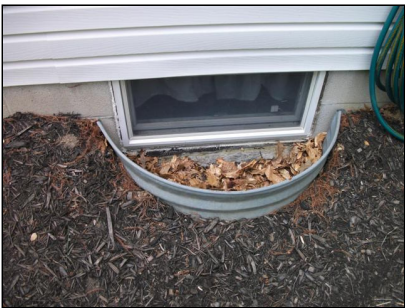
**10.7** The home has window wells. *I recommend a proper window well cover be installed at each applicable location to help deflect water away from the homes foundation. Water intrusion may occur in the home at a higher rate, if these are not in place and it is an easy first step to help prevent water intrusion problems. To be done by a qualified person or company.*
